CASE STUDY: INVESTIGATING THE 2013 ASIACELL WAREHOUSE STEEL PORTAL FRAME FAILURE

Razaq Ferhadi

doi:10.23918/iec2018.30

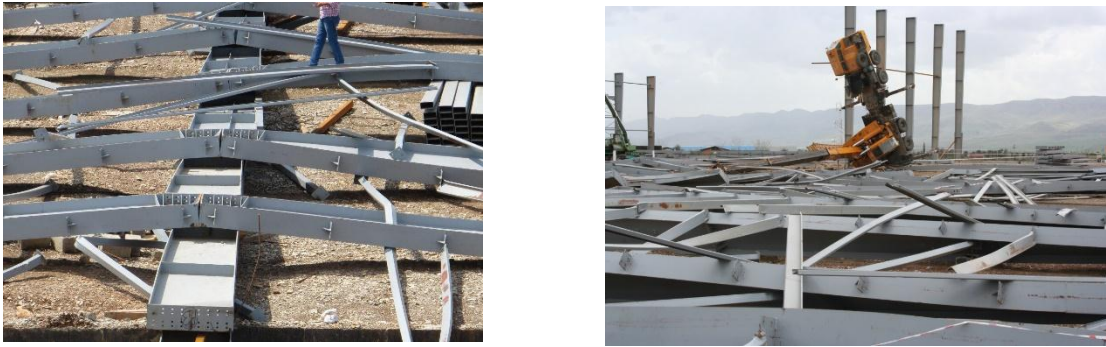
The 108m x 84m steel portal frame collapsed during construction as a result of a dynamic lateral load caused by the collapse of the 50 ton rough terrain crane and hitting one of the rafters. The rafter that was connected to the outer columns and fixed on the concrete via four anchor rods, collapsed under the impact as one piece frame and hit the adjacent frame section and caused a catastrophic abrupt-action collapse of the whole structure as a domino effect (Figure 2).

FIGURE 1. Collapsed Frame as Domino Action

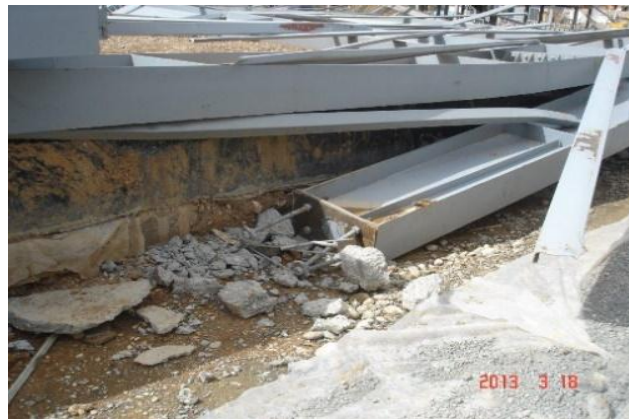
The representative core tests taken from the foundation on April 7, 2013 shows that the concrete passed the required compressive strength of 32 MPa. The results of the anchor rod analysis indicate that if they were installed as per the design drawings they were maintaining their structural integrity (Table 4). However, it is quite clear that the anchor rods failed to fulfill the requirements of the ASTM A307-97 since the elongation did not reach the lower limit [7]. According to ASTM A307-97, the minimum elongation percent in 50mm bar shall be 23% but the bars tested have elongations of 2.6%, 1.7%, and 1.4% as shown in Table 5. These values are too low. Based on the test results, although the tensile strength of the anchor rods has reached the required value, its elongation ratio did not meet the requirements. This has caused an abrupt pull out and/or premature ductile failure of the anchor rods which led the structure to collapse (Figure 11).

Therefore, the concrete crush is not from any glitches or quality from the foundation concrete but rather from the large impact pulling load that transferred almost wholly to concrete because the anchor rods failed to elongate as a ductile material.

FIGURE 11. Anchor Rod Pull-Out Fail

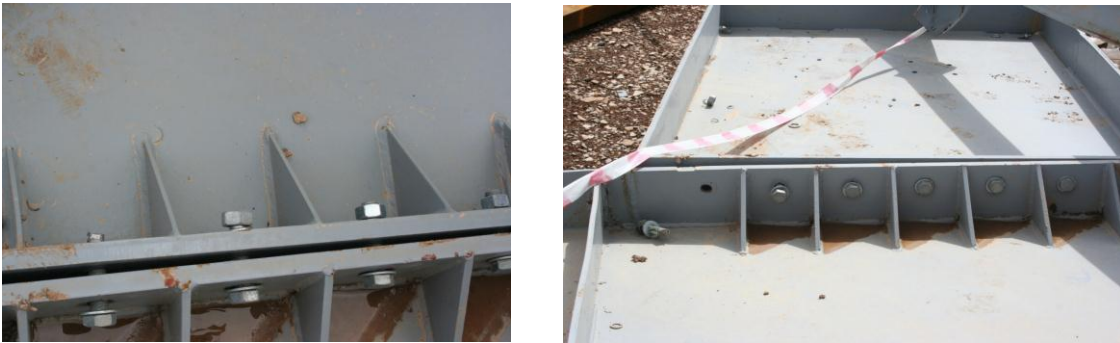
It was noticed during the field trip that the rafter-column connection bolts were not snug tight and lacked the appropriate torque. This was noticed in several connections (Figure 12). This loose connection caused bolt thread failure in shear in some of these connection and bolt threads totally or partially sheared away as the result of the large dynamic impact from the collapsed members (Figure 13).

FIGURE 12. Snug Tight Connection During Construction

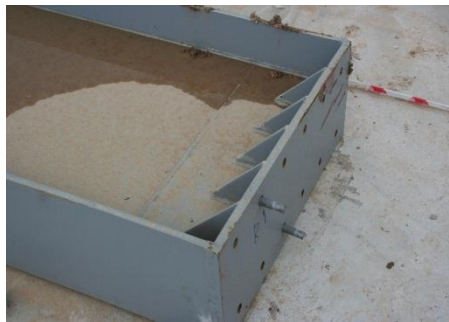
FIGURE 13. Shear Failure of Bolt Threa

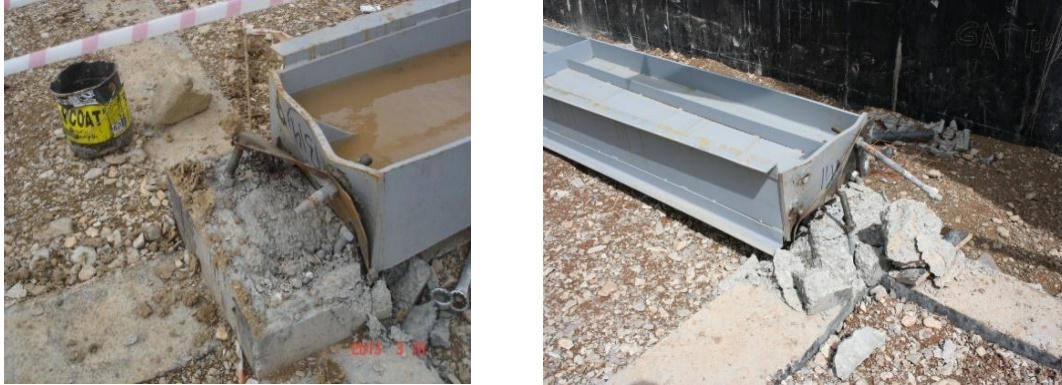
As mentioned above in The Structural Analysis section, few anchor rods at the frame sections close to the assembly crane failed and caused the collapse of the frame sections. Few of these anchor rod failures were ductile as shown in Figure 14 (left) while several others pulled out from the concrete as shown in Figure 14 (right). This can be caused by a glitch in the design of the anchor rods that caused the concrete to crush under the pull-out force (Figure 14 and Figure 15) or by construction negligence. However, as discussed in the design section, the laboratory tests showed that the bolt materials lacked elongation; as such, did not act as a ductile material and caused this pullout failure. Few base plates failed besides the anchor rods. Some of them bent, while some others went one step further by failing under tear through by the anchor rods (Figure 16).

FIGURE 14. Anchor Rod Failure, Ductile Failure (left) and Non-Ductile Failure (right)

Anchor bolts must be designed to be ductile. To do this, the designing pullout strength of the concrete failure cone (U_p) must be equal to the minimum specified tensile strength ($F_u A_t$) (Shipp & Haninger, 1963). Unfortunately, this was not the case in this structure.

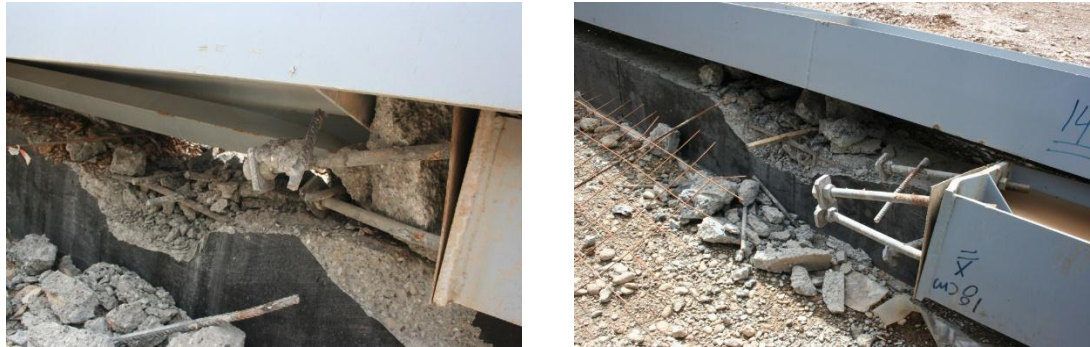
FIGURE 15. Anchor Rod Pull-Out and Concrete Crush Failure

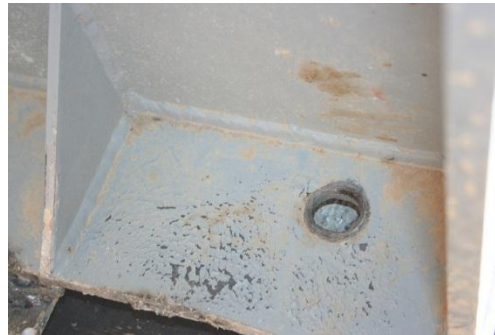
The base plate design evaluation shows that they have been designed to maintain their structural integrity for the applied loads. This indicates that the anchor rods were not tightened as required that permitted a dynamic impact on the anchor rod holes (Figure 16). On the other hand, the construction process of casing the pedestals that contained the anchor rods lacked quality work and common practice.

FIGURE 16. Base Plate Tear Through Failure

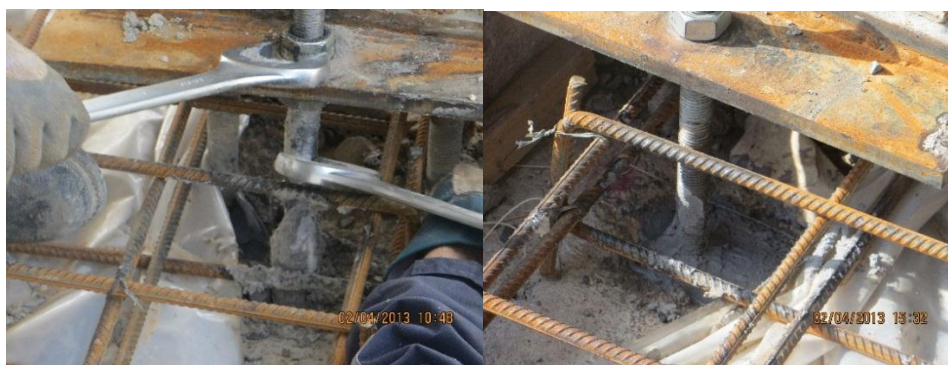
Despite having small height, it was noticed that the foundation pedestals were not casted monolithically with the rest of the foundation but rather after casting the footing. This can be noticed from Figure 18 that a gap was left underneath the top plate that was filled with concrete after casting a portion of the pedestal. This created a construction joint not so far from the top plate and the contractor was not able to vibrate that portion of concrete and made it prone to having voids in the pedestals.

FIGURE 18. Actual Pedestal Casting

The pedestals that contained the anchor bolts were fairly short and was much better to cast them monolithically with the tie beams. The ideal method to cast the pedestals monolithically with the other parts of the foundation and install the anchor rods is by leaving a hole through

the top leveling plate to allow the pedestals to be casted concrete monolithically with the other parts of the foundation (Figure 17).

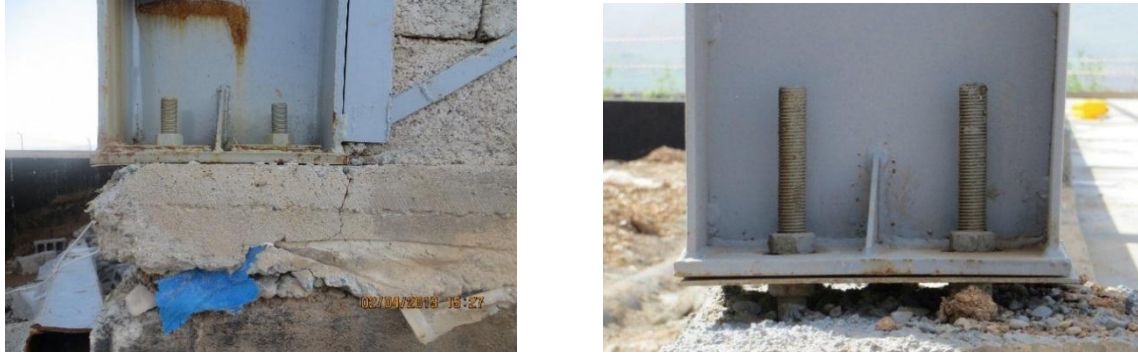
In few column bases, it was noticed as shown in Figure 19 that the gap underneath the column base plate was filled when the floor slab was cast and therefore, created a weak joint between the old concrete of the pedestal that connects to the tie beams and that portion of it that is above it. This is also an indication that normal common practice was not followed and the construction process lacked quality. In addition, the construction management was poor. The bolts should have been tested in a certified laboratory and the designers' approval should have been taken prior to using them. Also, the manufacturer's certification is missing for the rest of materials used such as the nuts, washers, etc. As such, this flaw is a glitch in the construction management of the project that should become lesson-learned for future similar projects.

FIGURE 19. Gap Under Base Plates Casted with Floor

- VI. The gap underneath the column base plate was filled when the floor slab was cast and therefore, created a weak joint between the old concrete of the pedestal that connects to the tie beams and that portion of it that is above it. As such, the weak spot in the anchor embedment was participated in the concrete breakout mechanism as per part iii of Figure RD.4.1 of ACI Code 318 [6].
