CASE STUDY: INVESTIGATING THE 2013 ASIACELL WAREHOUSE STEEL PORTAL FRAME FAILURE

Razaq Ferhadi

doi:10.23918/iec2018.30

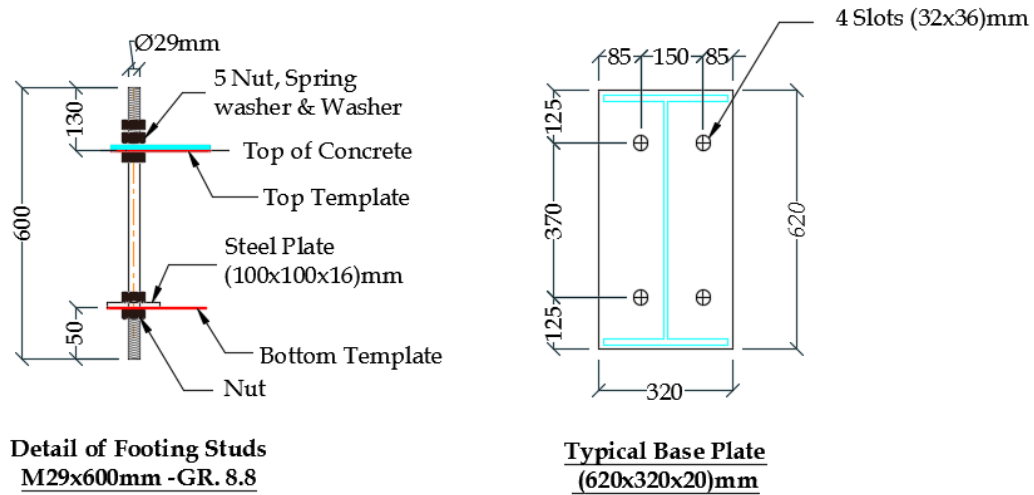
FIGURE 9. Anchor Rod and Base Plate Details

13. Foundation Connections: The main columns were designed to be connected to the foundation through four $\phi 29$, 600mm long anchor rods that were embedded 470mm in concrete. The base plates were 620mm x 320mm x 20mm (Figure 9).

The representative core tests taken from the foundation on April 7, 2013 shows that the concrete passed the required compressive strength of 32 MPa. The results of the anchor rod analysis indicate that if they were installed as per the design drawings they were maintaining their structural integrity (Table 4). However, it is quite clear that the anchor rods failed to fulfill the requirements of the ASTM A307-97 since the elongation did not reach the lower limit [7]. According to ASTM A307-97, the minimum elongation percent in 50mm bar shall be 23% but the bars tested have elongations of 2.6%, 1.7%, and 1.4% as shown in Table 5. These values are too low. Based on the test results, although the tensile strength of the anchor rods has reached the required value, its elongation ratio did not meet the requirements. This has caused an abrupt pull out and/or premature ductile failure of the anchor rods which led the structure to collapse (Figure 11).

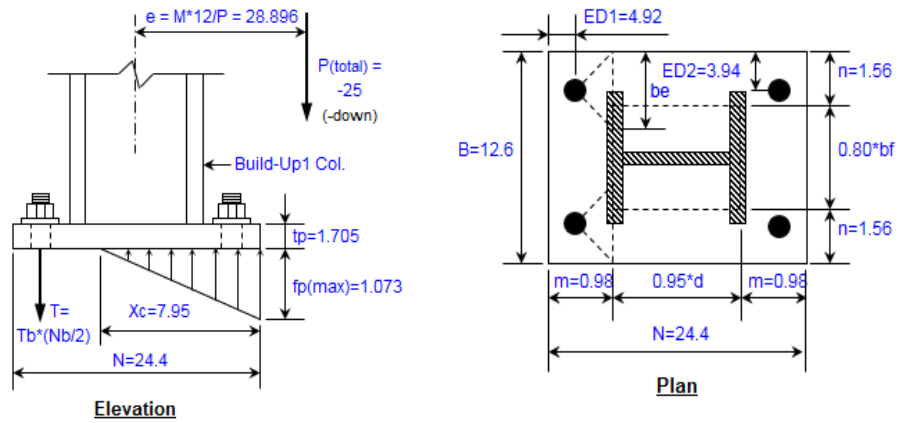
FIGURE 10. Base Plate Analysis

Base Plate Analysis: Base plates are analyzed using AISC ASD9 methodology. For that, the load combinations in the Autodesk Robot Structural Analysis Professional are changed to ASD. The results of the reaction forces are calculated and the envelop values are taken as conservative approach to evaluate the base plates. These envelop values are shown in Table 3 and Figure 10.

These values are inserted in an Excel sheet created specifically to analyze the base plates. The results show that the base plates are capable to resist the loads and maintain their structural integrity as follows. Note that the bearing pressure is exceeded the allowable by approximately 2%, which is acceptable in this case.

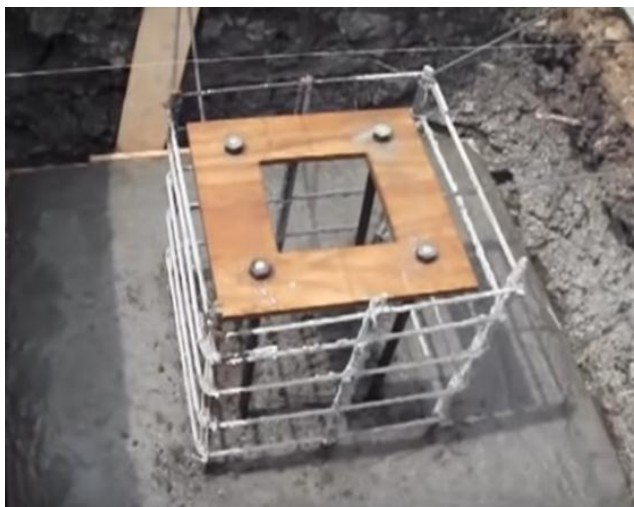
FIGURE 17. Typical Common Practice Pedestal Construction

the top leveling plate to allow the pedestals to be casted concrete monolithically with the other parts of the foundation (Figure 17).
